South Wales RIGS Group Site Record

General	South Wales
Site Name: Llanhilleth (Tirpentwys)	File Number: Site_BIGC_11
RIGS Number: 589	Surveyed by: Rhian Kendall, David Roberts
Grid Reference: SO 2340 0140	Date of Visit: 30 th September 2010
RIGS Category: Scientific	Date Registered:
Earth Science Category: Stratigraphic, sedimentological	Owner: Unknown Planning Authority: Torfaen County Borough Council and Caerphilly County Borough Council
Site Nature: Disused Quarry	Documentation prepared by: Rhian Kendall
Unitary Authority: Torfaen County Borough Council and Caerphilly County Borough Council	Documentation last revised: 24 th March 2012
OS 1:50,000 Sheet: 171	Photographic Record: Embedded in text
OS 1:25,000 Explorer Sheet: 152	
BGS 1:50,000 Sheet: 232/249	
RIGS Statement of Interest:	
<p>This site has been proposed as a RIGS as it is a good example of the Grovesend Formation of the Warwickshire Group in South Wales. It provides over 1km of exposure between the Mynnydd Islwyn and Small Rider Coals, providing opportunity to study this formation and the sedimentology of sediments deposited on alluvial floodplains in overbank lake environments. This site would also be of interest to

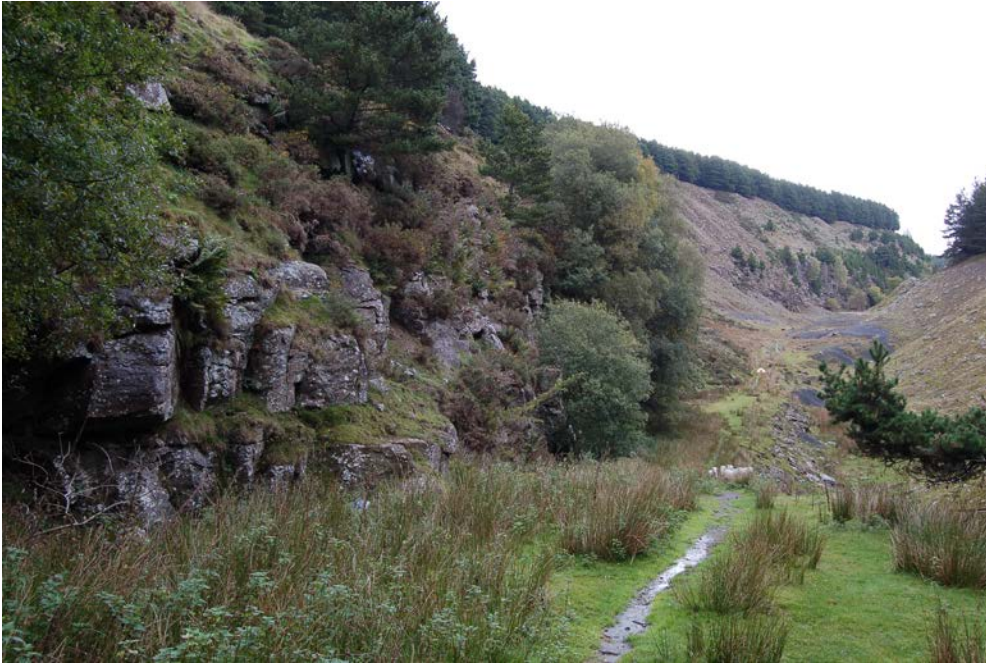
View from access. Photograph by David Roberts

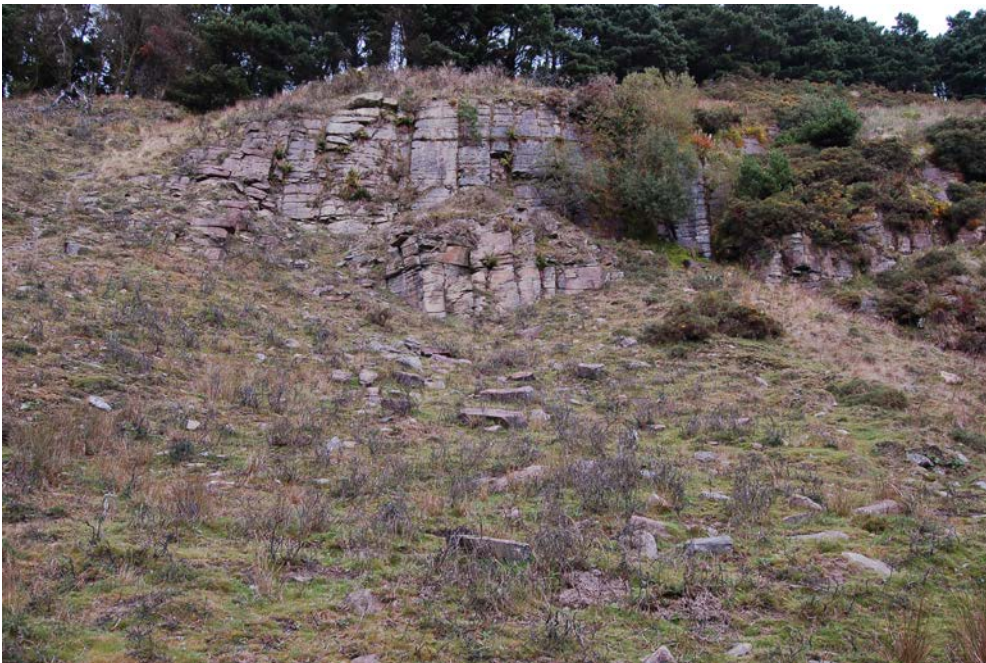
Bedded sandstone, joints and debris at west end. Photograph by David Roberts

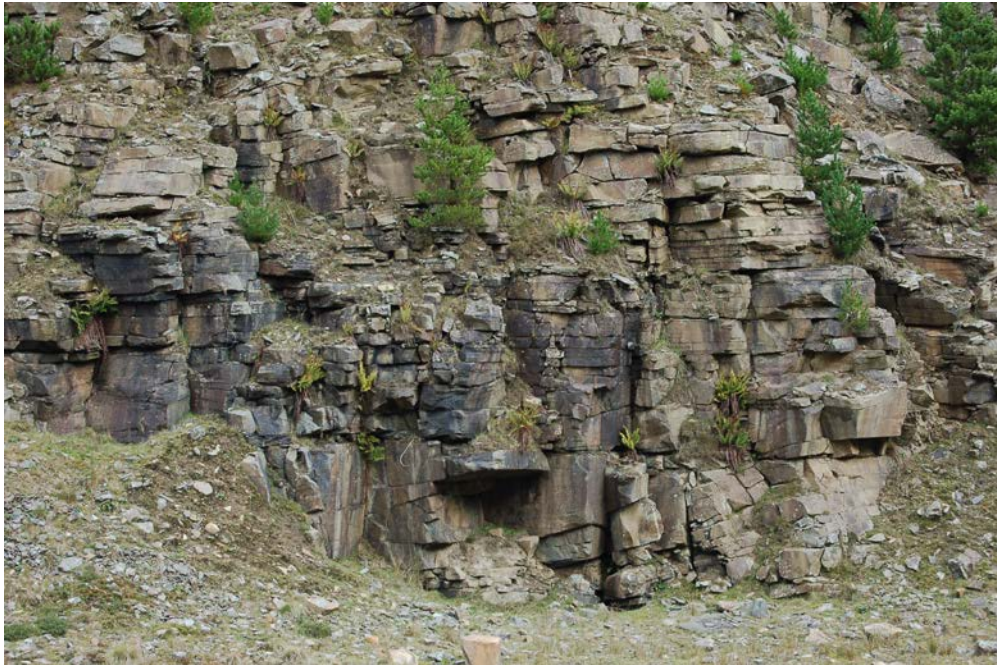
Bedded sandstone with many joints at west end. Photograph by David Roberts

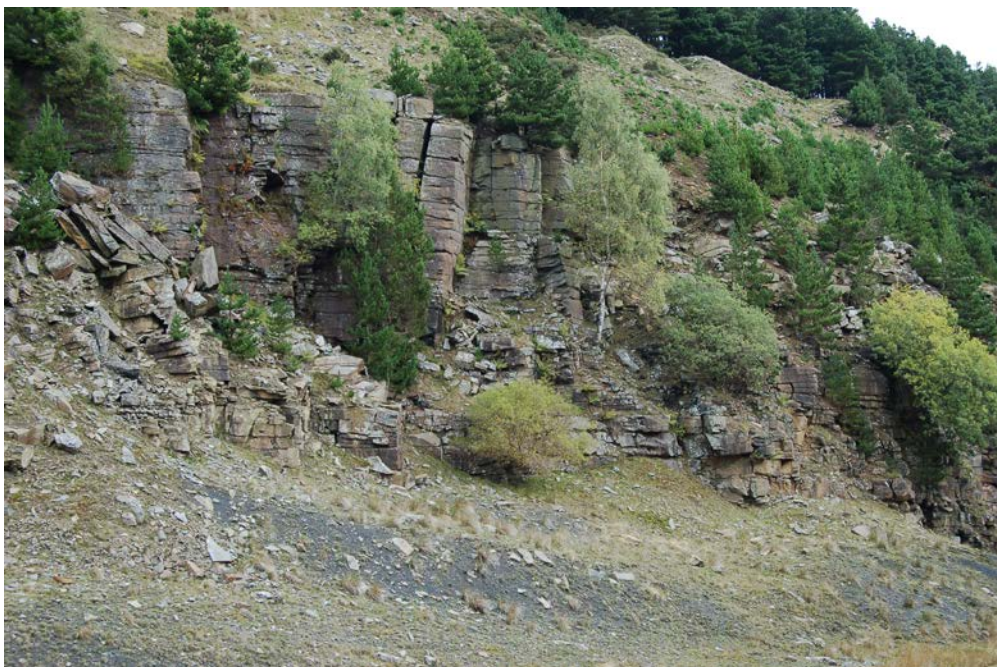
Toppling in Sandstone. Photograph by David Roberts

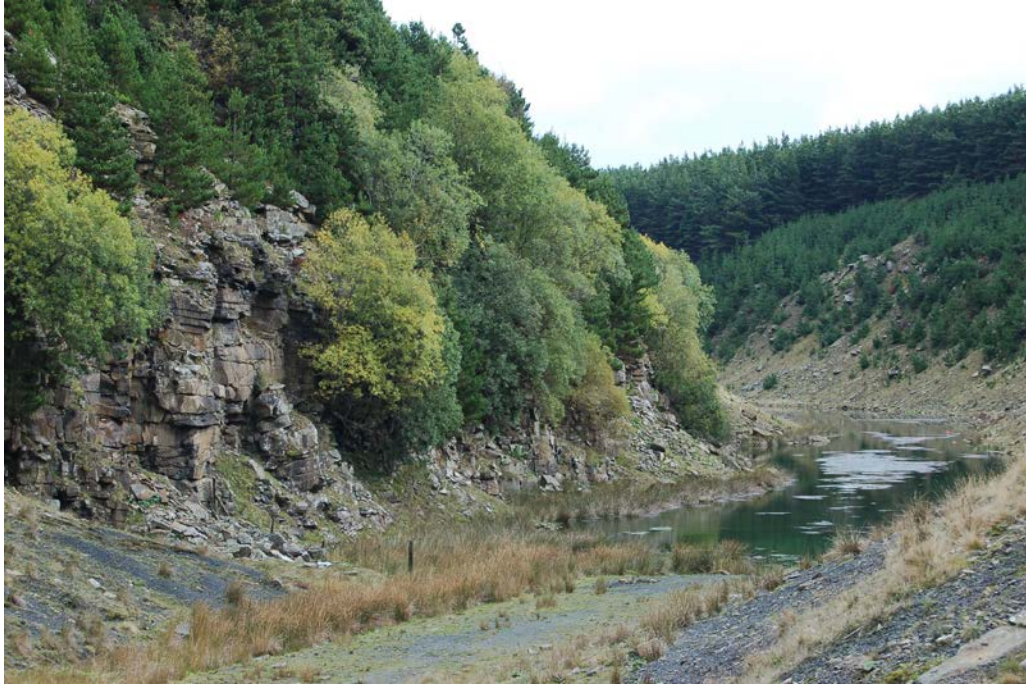
View of site from west showing lake, trees, the difficult access and working conditions. Photograph by David Roberts

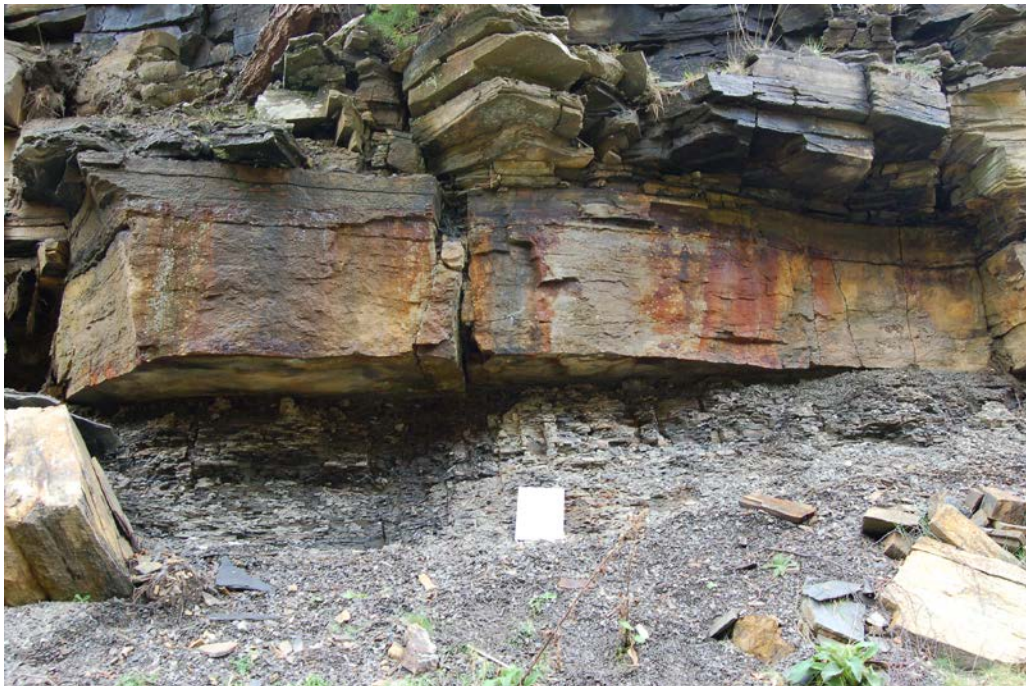
Base of sandstone overlying shales. Photograph by David Roberts

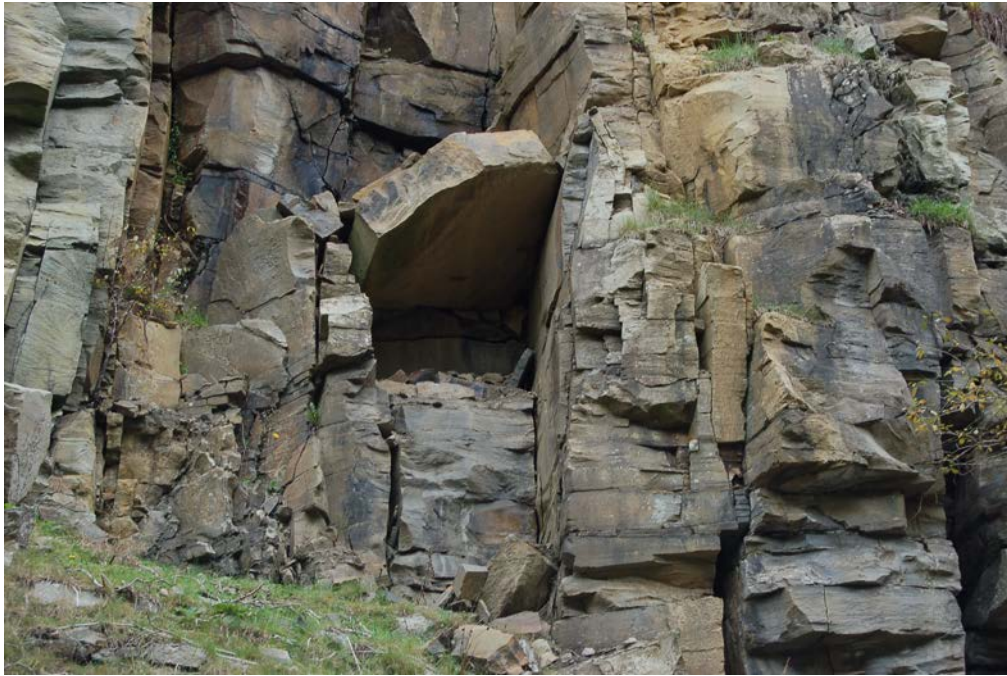
Unstable face with suspended block (E side). Photograph by David Roberts

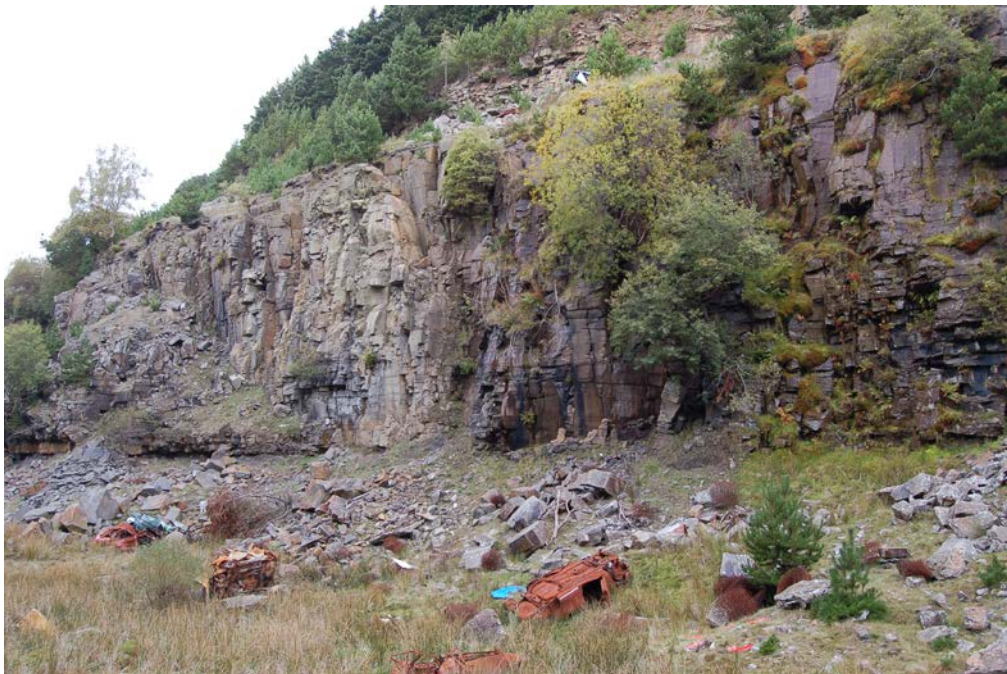
East end of face showing very poor stability of vertical faces, strong master joints, a higher level bench which is not accessible safely and wrecked cars on the floor. Photograph by David Roberts

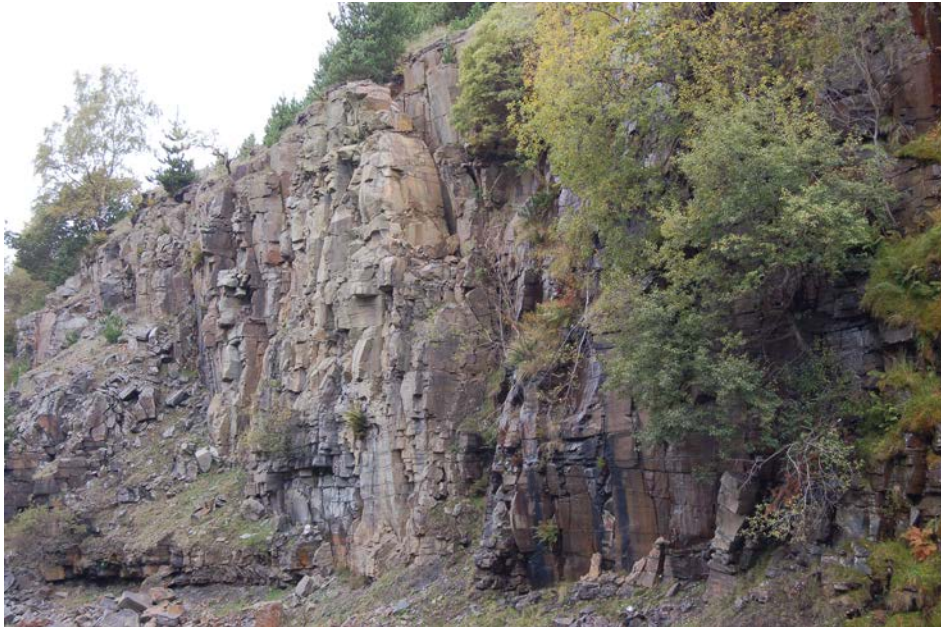
Poor face stability and toppling. Photograph by David Roberts

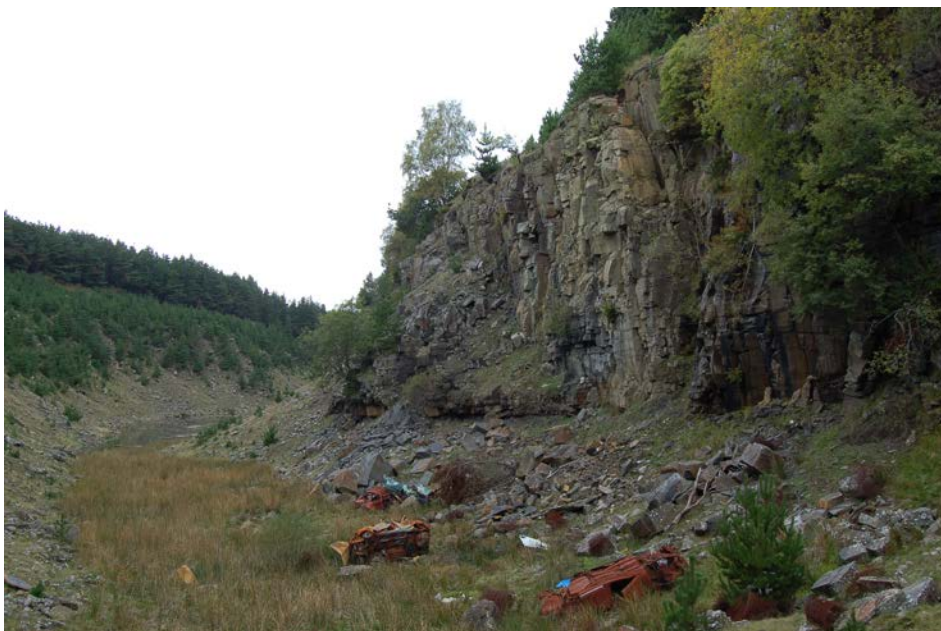
View to west showing base of sandstone. Photograph by David Roberts

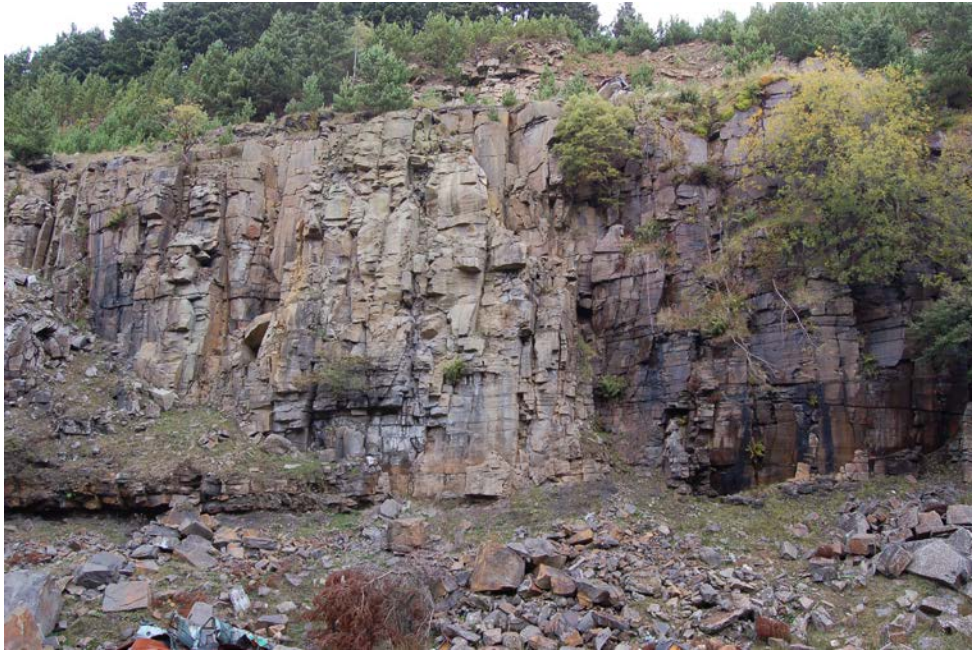
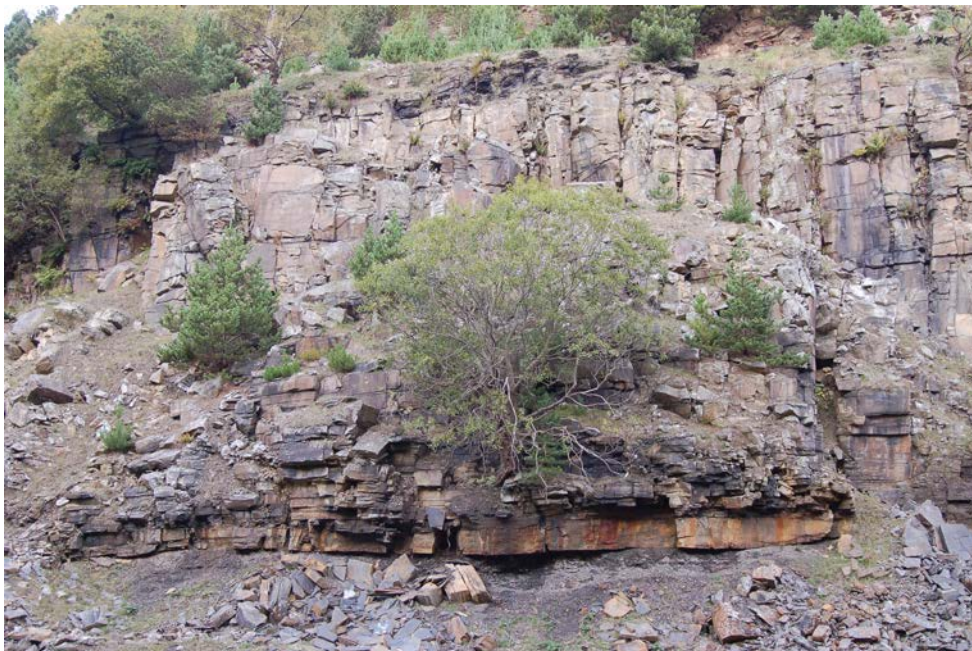
Sandstones at east showing dangerous faces. Photograph by David Roberts

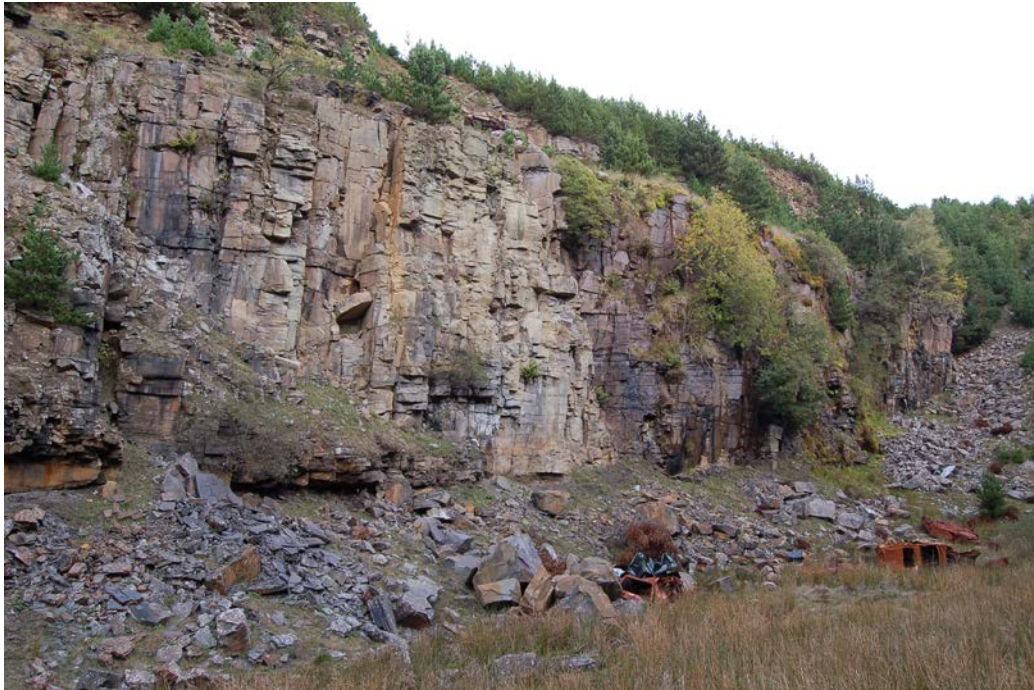
Unstable east end of site showing loose blocks and evidence of recent collapse.
Photograph by David Roberts

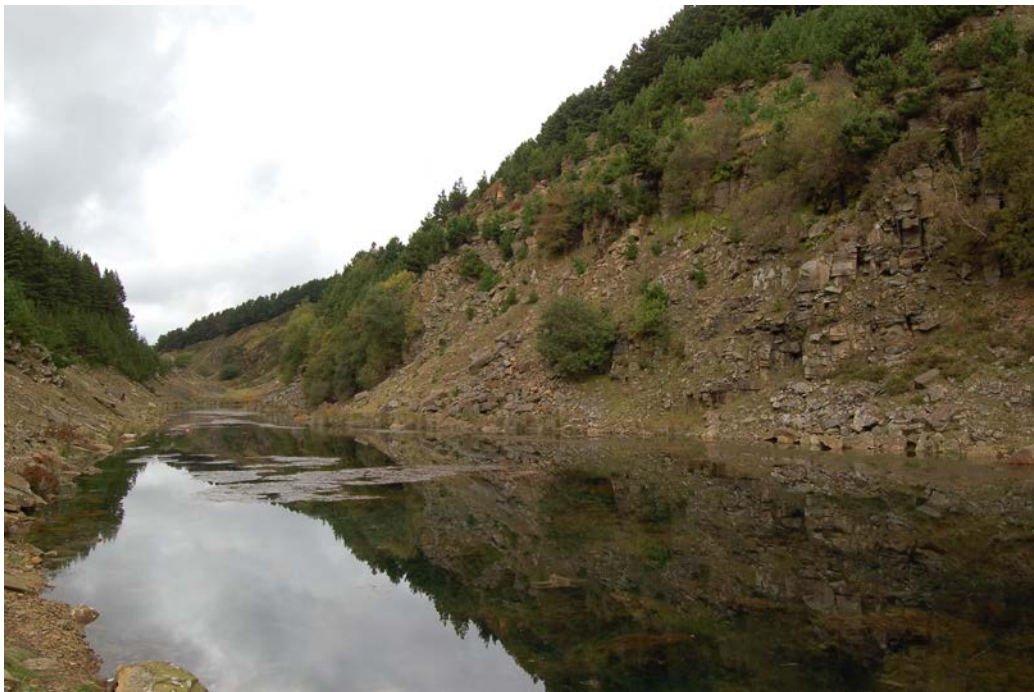
View of lake to east. Photograph by David Roberts

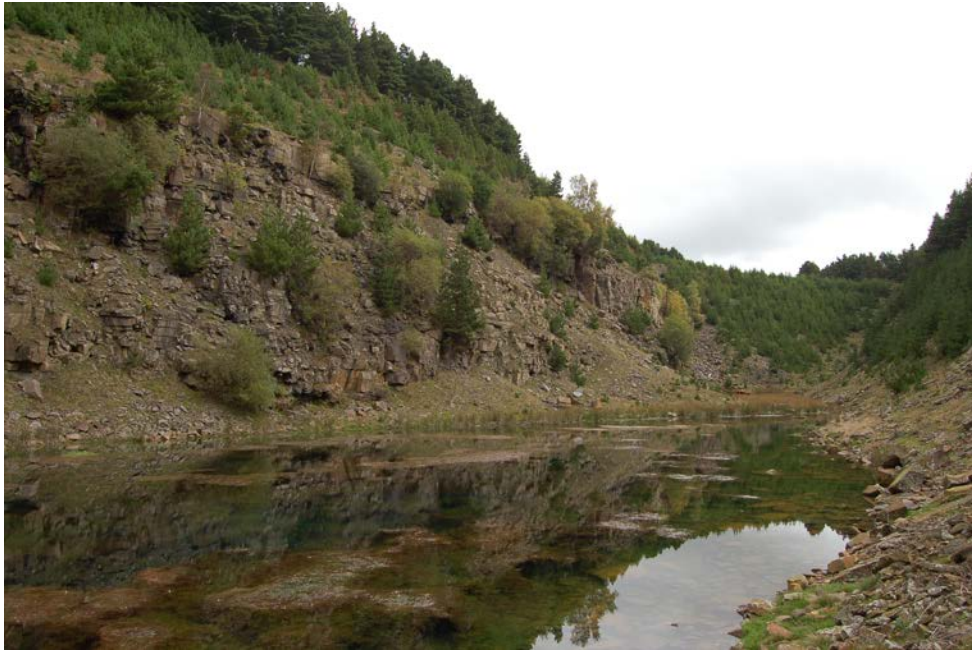
View of water to west. Photograph by David Roberts

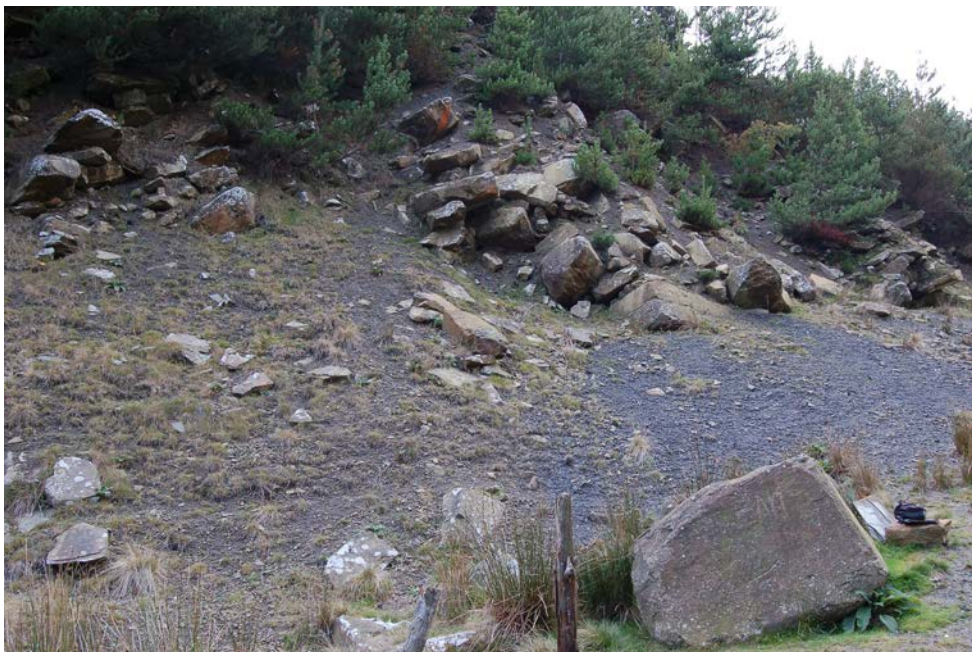
Sandstone in tip. Photograph by David Roberts

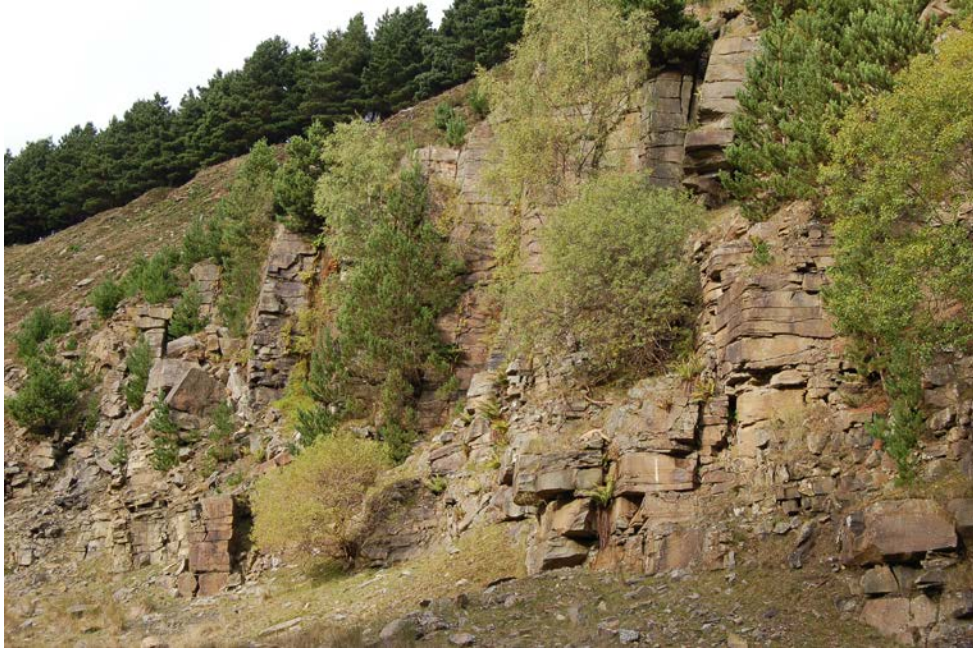
Sandstone at west end of site. Photograph by David Roberts
