South Wales RIGS Group Site Record RIGS Description

General	South Wales
Site Name:	File Number:
Castell Coch Quarry	SITE_CCC_34
RIGS Number:	Surveyed by:
634	South Wales Geologists' Association
Grid Reference:	Date of Visit:
ST 1300 8261	4 th August 2007
RIGS Category:	Date Registered:
Scientific, historical	Owner: Unknown
Earth Science Category:	Planning Authority: Cardiff County
Stratigraphic, Historical	Council
Site Nature:	Documentation prepared by:
Disused Quarry	Linda Garfield and Rhian Kendall
Unitary Authority:	Documentation last revised:
Cardiff County Council	1 st Sept 2009
OS 1:50,000 Sheet: 171	Photographic Record:
	Attached
OS 1:25,000 Explorer Sheet: 151	
BGS 1:50,000 Sheet: E249

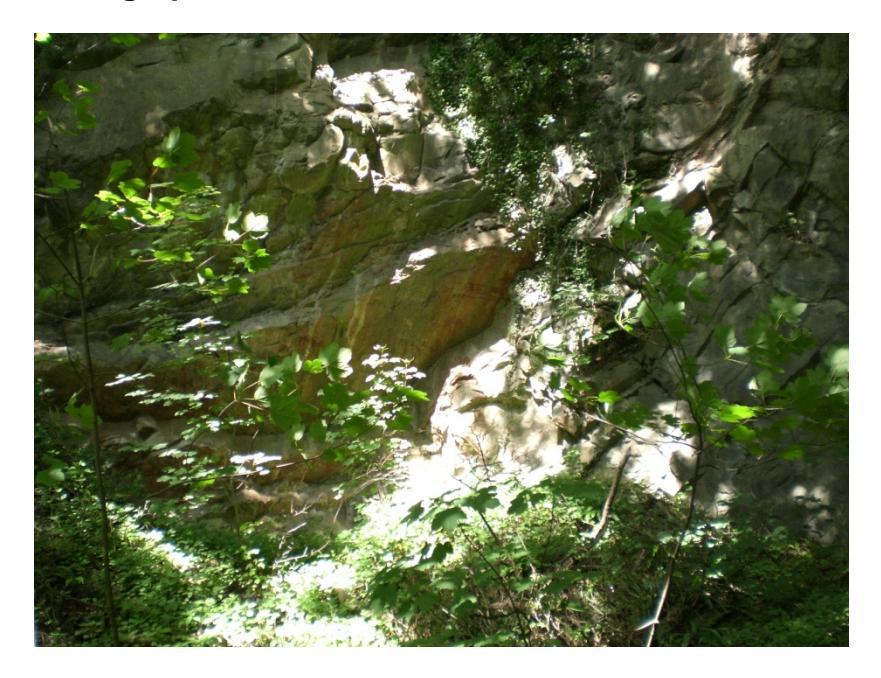
Thick bedded limestones of the Castell Coch Limestone Formation are exposed in east face of this narrow, E/W linear quarry, below the castle. A small fault is visible and a large nodular bed. Dolomitization and hematite staining occurs. Shales are exposed on north face, especially where recent slips have occurred. This is the type locality of the Castell Coch Limestone Formation.

Main face Castell Coch Quarry

Site Management: Suggest that selected parts of this site are cleared of vegetation and rubbish every few years. Prohibit rubbish dumping.

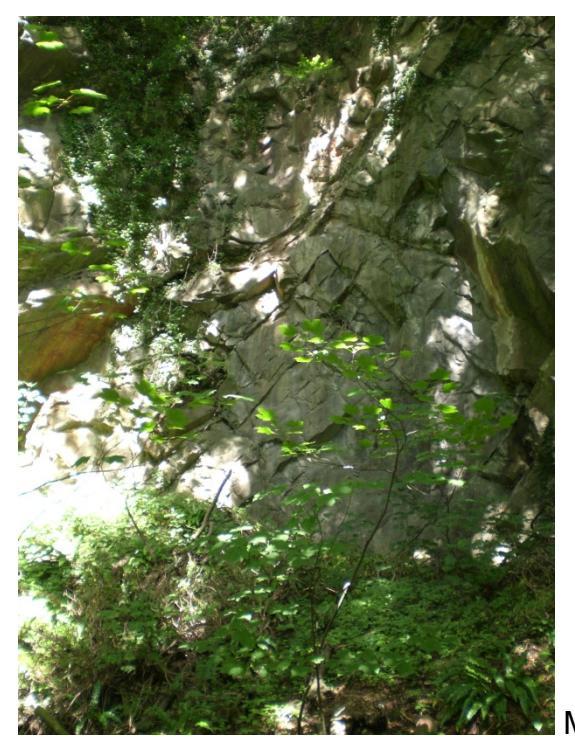
Site condition: The quarry floor is covered in scrub and rubbish (below castle) and the main face is becoming covered by ivy and other vegetation.

Main face Castell Coch Quarry

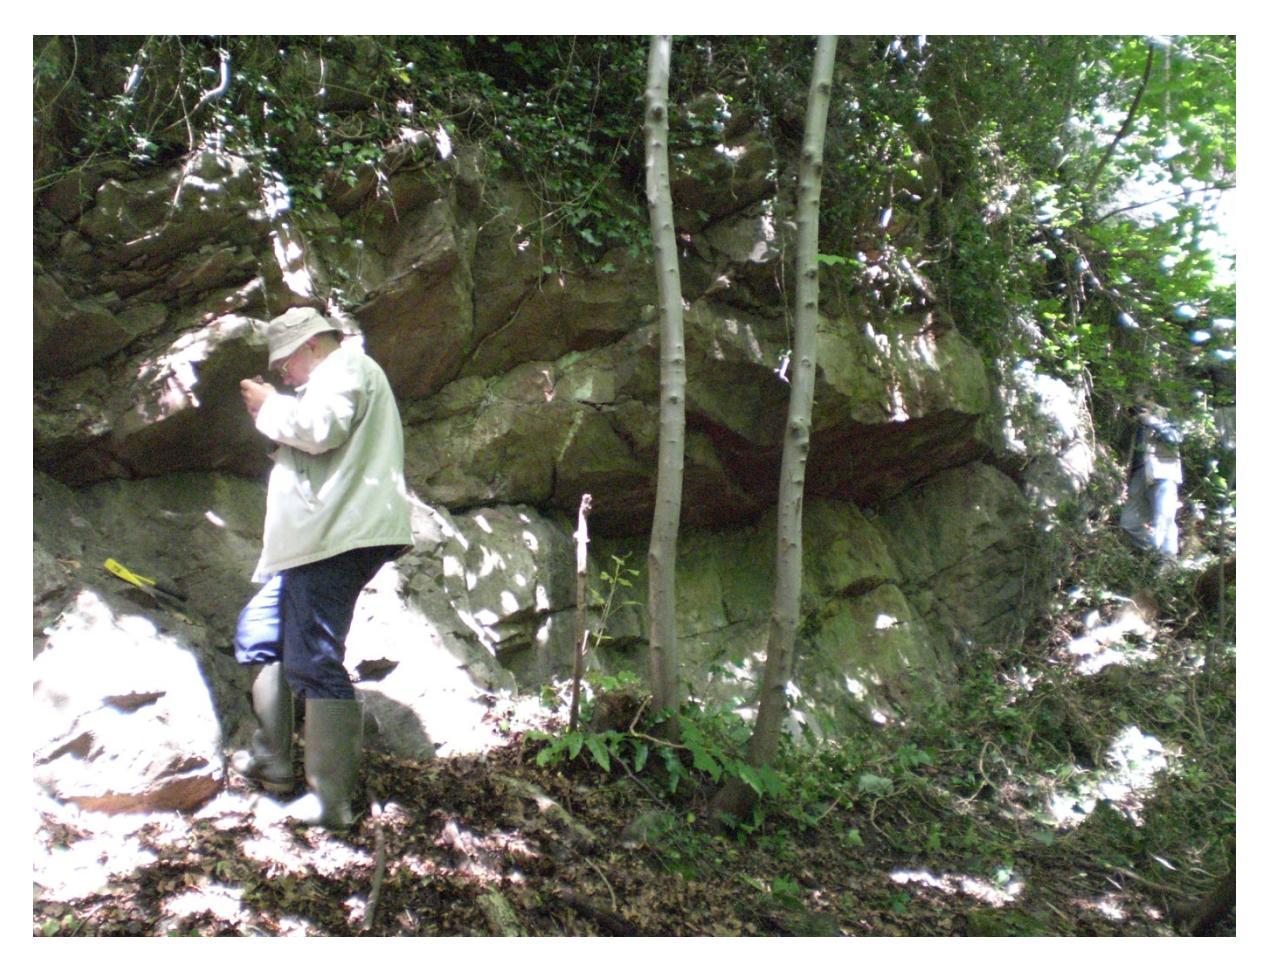
Lower parts of Castell Coch Quarry
