# South Wales RIGS Group Site Record RIGS Description

| General | South Wales | |
|--|--|--|
| Site Name: Rosehill Quarry Community Park | File Number: Site_247_48 | |
| RIGS Number: 771 | Surveyed by: Rhian and Andy Kendall | |
| Grid Reference: SS 64409 93474 | Date of Visit: 28 <sup>th</sup> January 2012 | |

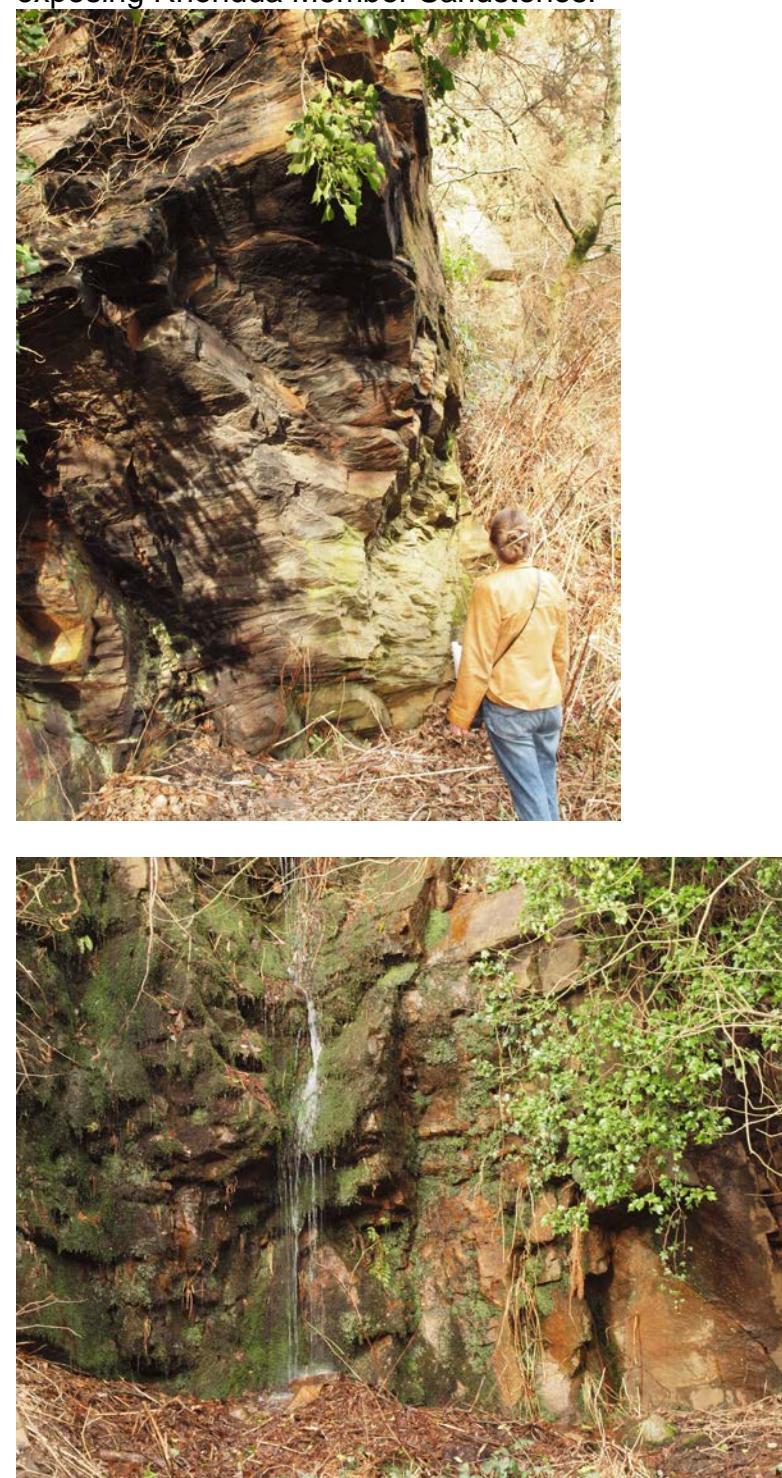
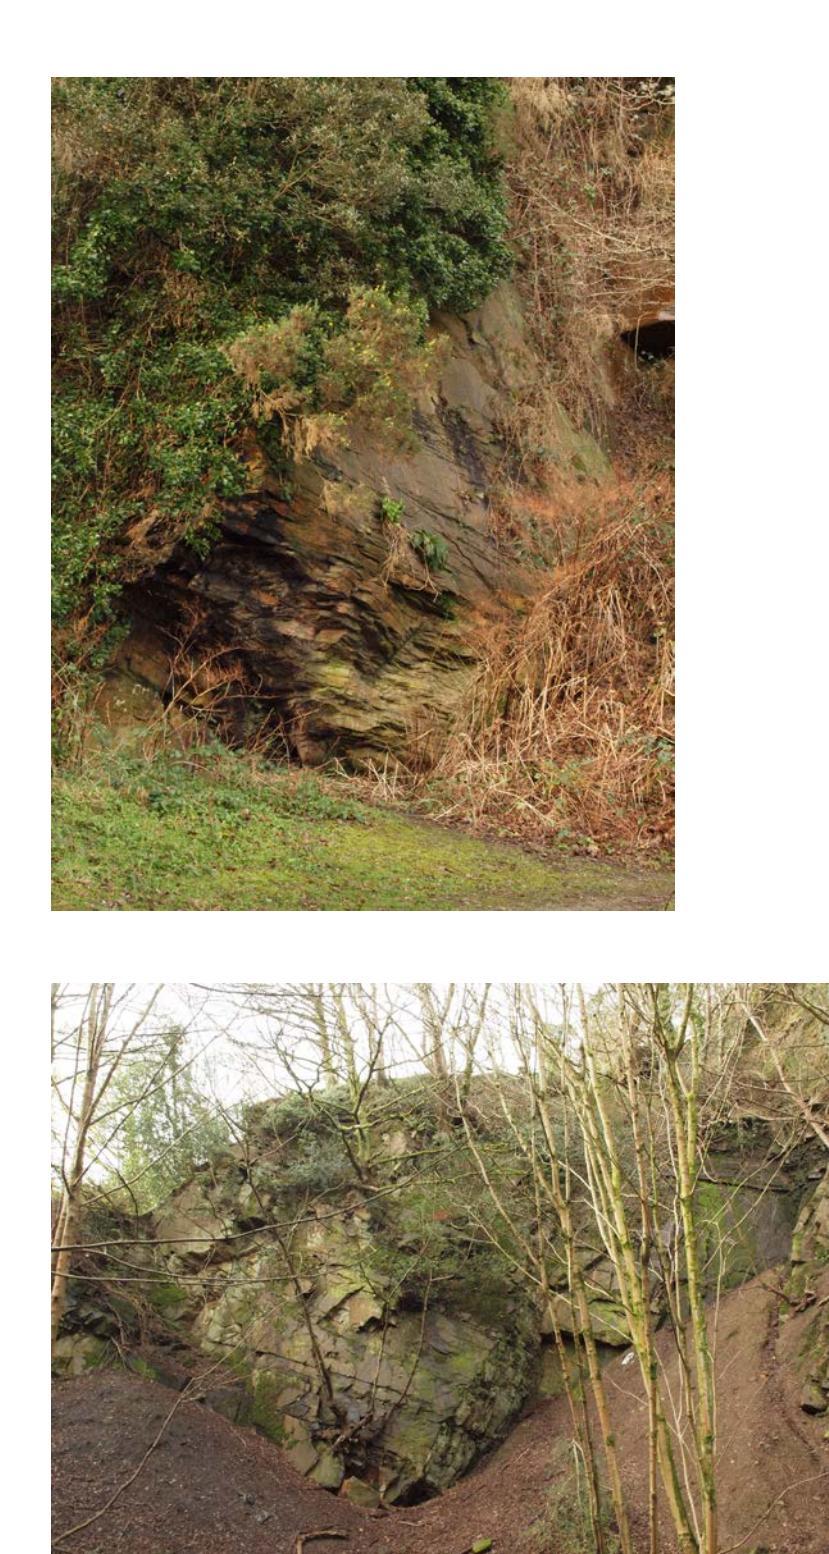
**Photographic Record** The following photographs illustrate the overgrown quarry faces in the quarry, exposing Rhondda Member Sandstones.

Site condition: Slightly overgrown in places

Potential threats: Becoming obscured by vegetation

**Site Management**: Recommend that faces are tidied up in consultation with ecologist to ensure biodiversity interest is also maintained
