## South Wales RIGS Group Site Record RIGS Description

3201		
General	South Wales	
Site Name: Allt-yr-yn Quarry	File Number: DS_249_113	
RIGS Number: 773	Surveyed by: Tom Sharpe and Janet Hiscott	
Grid Reference: ST 29004 88576	Date of Visit: 3rd May 2009	
RIGS Category: Scientific	Date Registered:	
Earth Science Category: Stratigraphic,	Owner: Unknown	
Palaeontological	Planning Authority: Newport City Council	
Site Nature: Disused Quarry	<b>Documentation prepared by:</b> Tom Sharpe	
Unitary Authority: Newport City Council	Documentation last revised: June 2012	
<b>OS 1:50,000:</b> 171	Photographic Record: Attached	
<b>OS 1:25,000:</b> 152		
BGS 1:50,000: 249

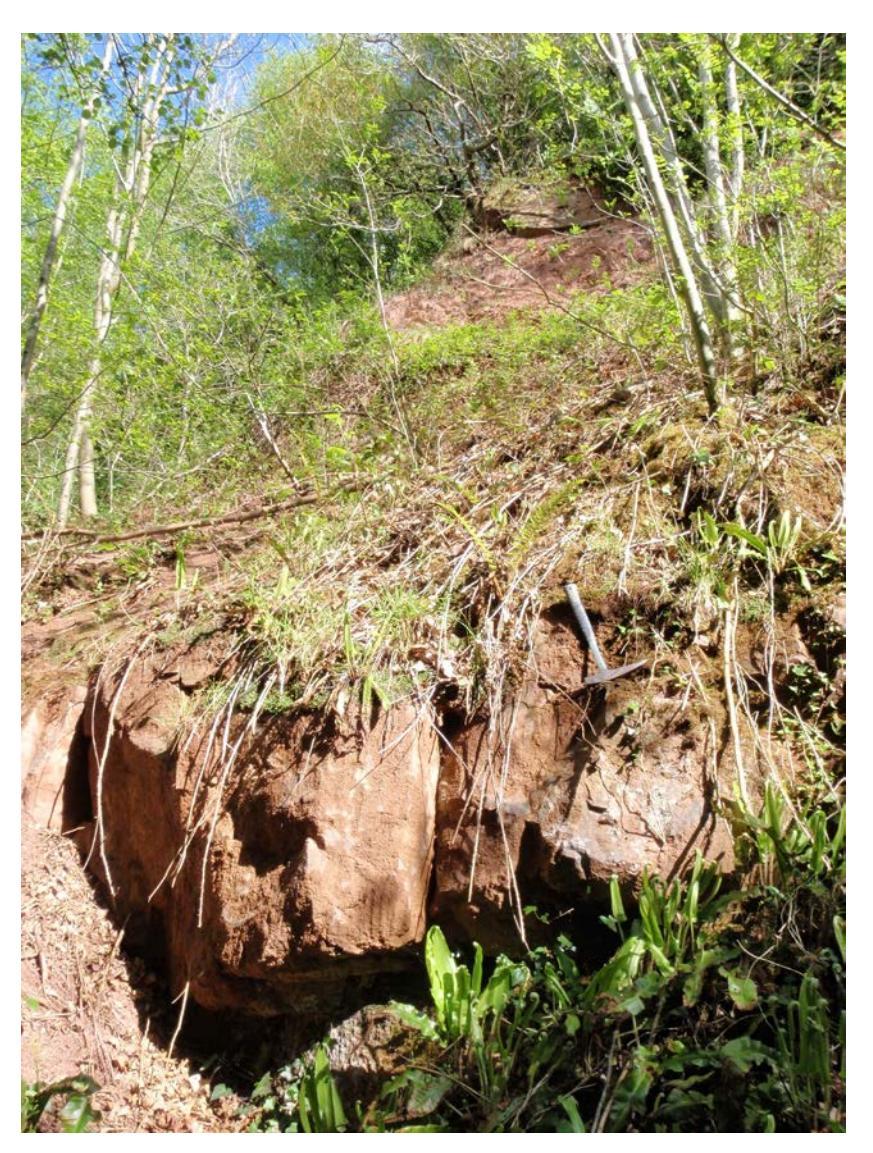
At the present time, the eastern part of this outcrop is a high quarry face, partly overgrown, of red mudstones with several prominent sandstones. The lowermost sandstone is a massive, 1.5 m thick, purple micaceous sandstone resting on red mudstone. Above this more red mudstone is overlain by a more flaggy sandstone which overhangs at the top of the cliff.

Ally-yr-yn main quarry face (photograph Tom Sharpe)

Site Management: Site would benefit from being cleared of vegitation

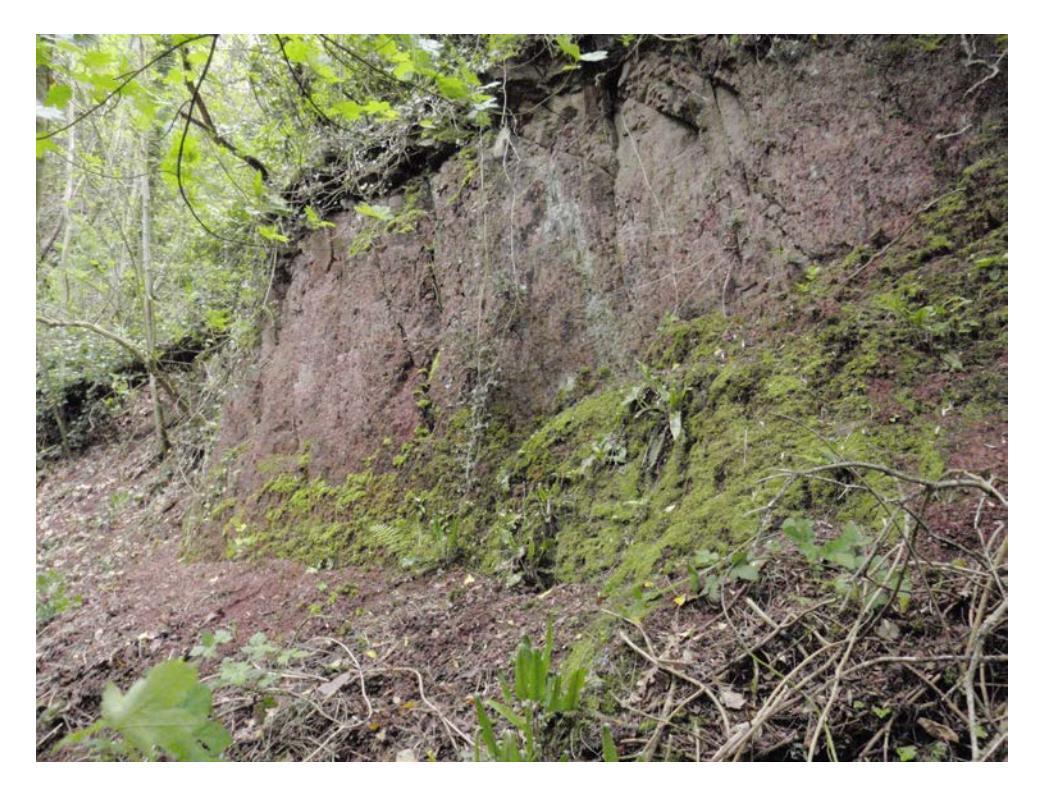
The lower part of the sequence near the steps comprises about 6m of red micaceous blocky mudstone with some sandstones. Grey-green reduction tubes in mudstones represent plant roots in a palaeosol. This exposure is 20m in length.

Palaeosols near base of the section (photograph Tom Sharpe)

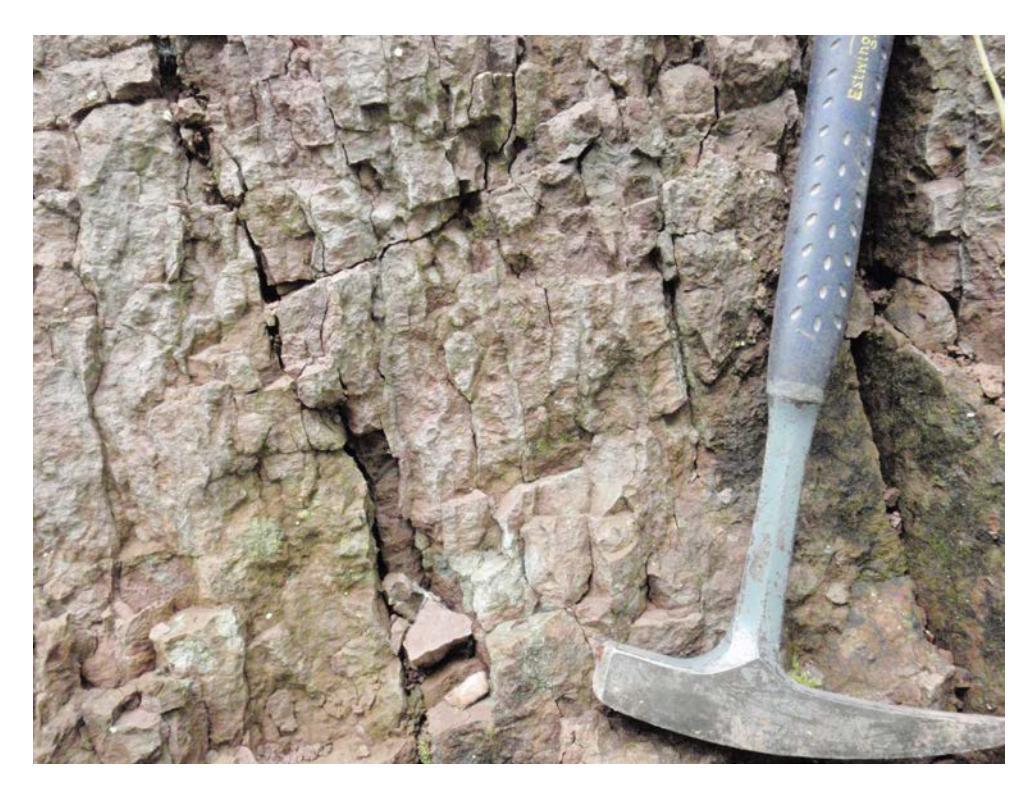
Also of interest at this site are the grey-green reduction tubes in mudstones representing plant roots in a fossil soil.

Reduction pipe – palaeosol features near base of section (photograph Tom Sharpe)
